## SUNDUMBILI MAGISTRATE OFFICE: ADDITIONAL ACCOMMODATION

# GEOTECHNICAL REPORT

***Report to Singh Govender & Associates on the Results of  
an Augmented Geotechnical Investigation for the Proposed  
Additions to the Sundumbili Magistrates Court, near  
Mandini, iLembe District Municipality, KwaZulu-Natal***

***Reference: 269-16.R02***

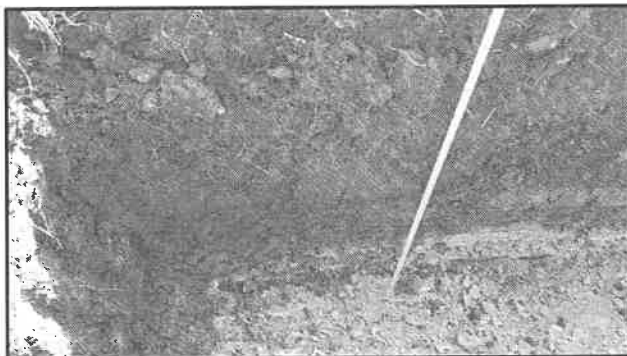
**Plate 6:** Typical soil and rock profile observed at IP1.

- a. **Fill** - Light brownish grey, loose to medium dense, fine to medium grained, silty to slightly clayey SAND with occasional gravel and roots. Fill was observed at IP1, IP2 and IP7, to occur from EGL to depths in the range 0.2m to 0.4m below EGL.

- d. **Weathered tillite bedrock** - Light yellow stained rusty brown, highly weathered, highly fractured, very soft-to-soft rock / light brown to dark brown blotched orange and olive occasionally streaked grey, moderately to highly weathered, very highly to highly fractured, soft to medium hard rock. Weathered tillite bedrock was observed at all of the inspection pits and boreholes profiled to commence from depths between 0.5m (IP5 refers) to 1.7m (IP8 refers).

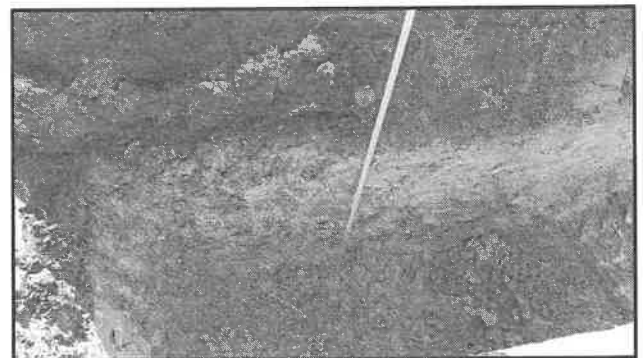
**Plate 7:** Typical soil and rock profile observed at IP6.

- b. **Colluvium** - Light brownish grey, firm, intact, sandy CLAY with fine roots. Colluvium was observed at IP3, IP4, IP5, IP6 and IP8, to occur from EGL to depths in the range 0.20m to 0.45m below EGL.

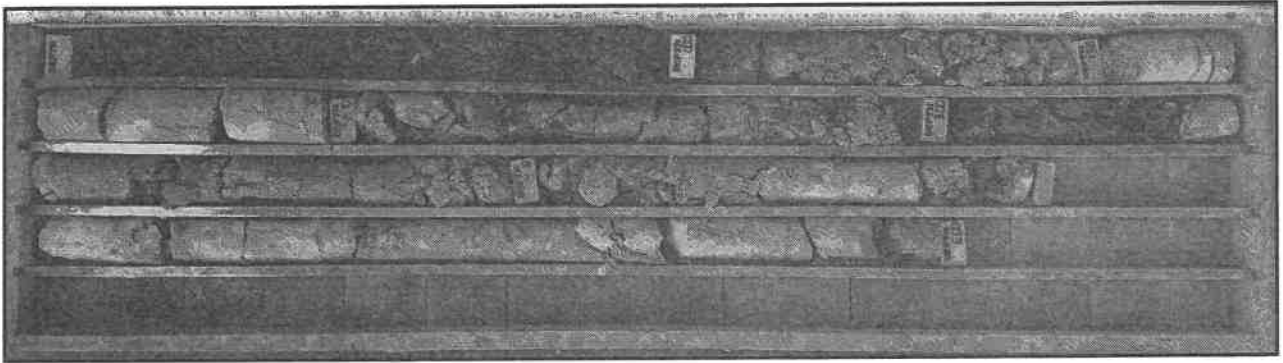
**Plate 8:** Soil and rock samples retrieved during the drilling of borehole BH1.

Inferring from the borehole samples, “soft to medium hard” tillite bedrock occurs from depths in the range 1.50m to 2.5m below EGL. Actual founding levels will be dependent on any geological variations within the weathered tillite bedrock and final platform levels.

Inferring from the results of the field investigation, it is considered that the reinforced spread/pad footings will be suitable for the proposed development. It is recommended that the foundation loads, measuring approximately 7000kN, be transferred through the overlying fill, colluvium, residuum and “very soft to soft” tillite bedrock to be founded on weathered tillite bedrock of at least “soft to medium hard” rock strength. On such founding medium, a maximum nett allowable bearing pressure of 1000kN/m<sup>2</sup> is considered applicable.

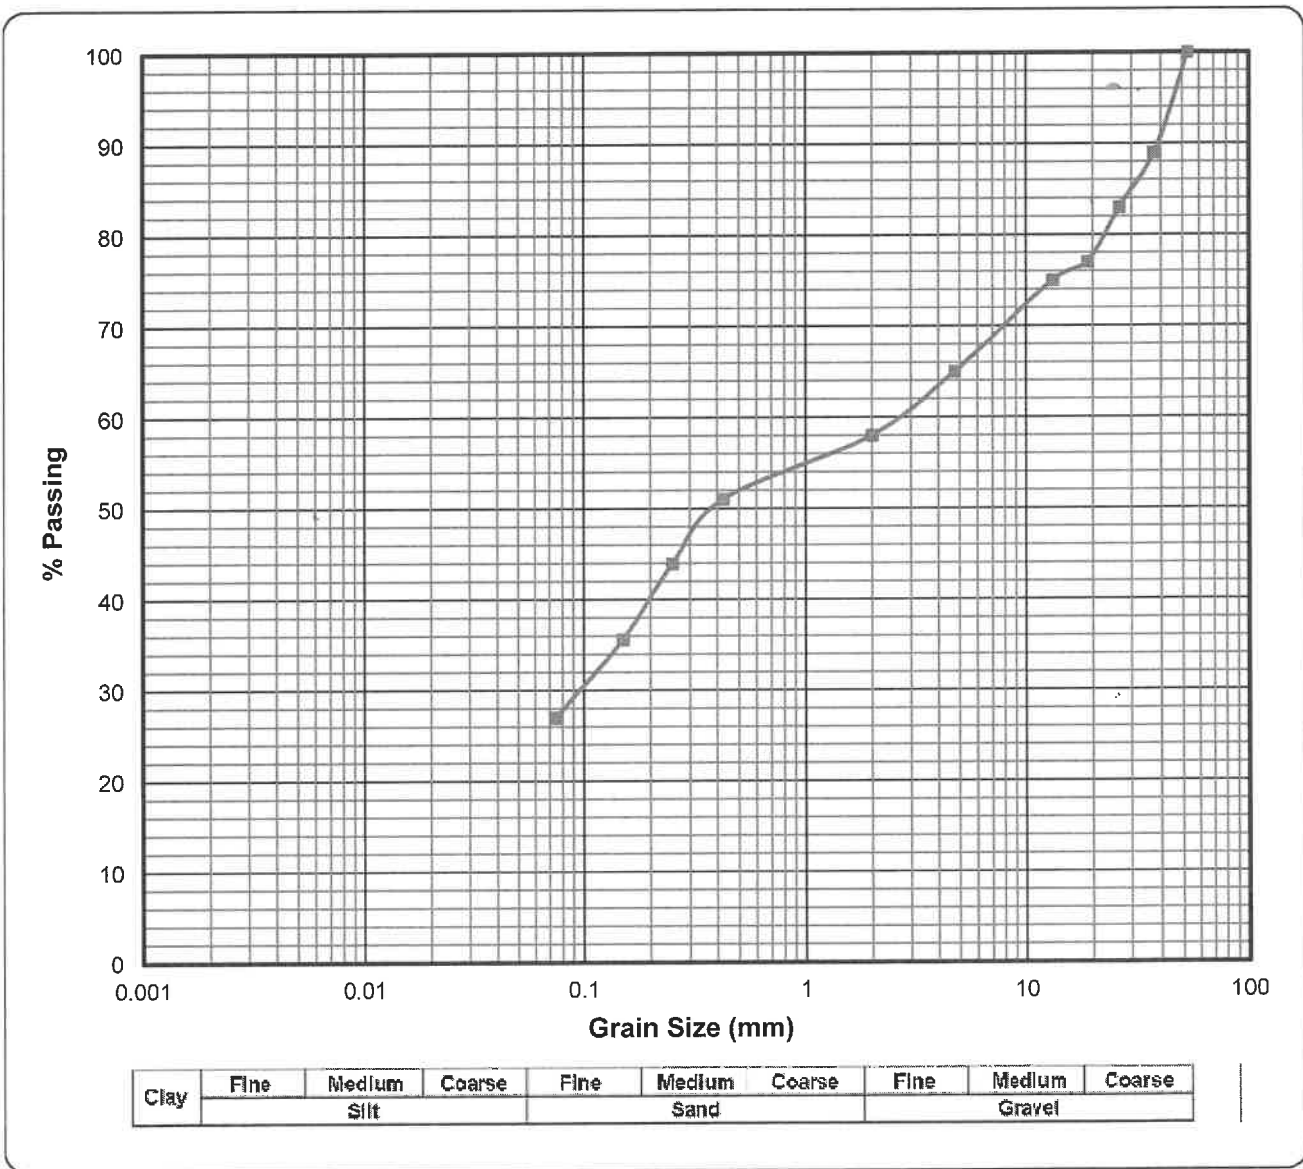
### Grading Curve for Sample 47879 – TMH1 Method A1 (a)

**Thick Red Line is the Grading Curve (TRH 14 Classification = G7)**

Sieve Aperture Size	0.075	0.150	0.250	0.425	2.00	4.75	13.2	19.0	26.5	37.5	53	63	75
Percentage Passing	27%	36%	44%	51%	58%	65%	75%	77%	83%	89%	100%

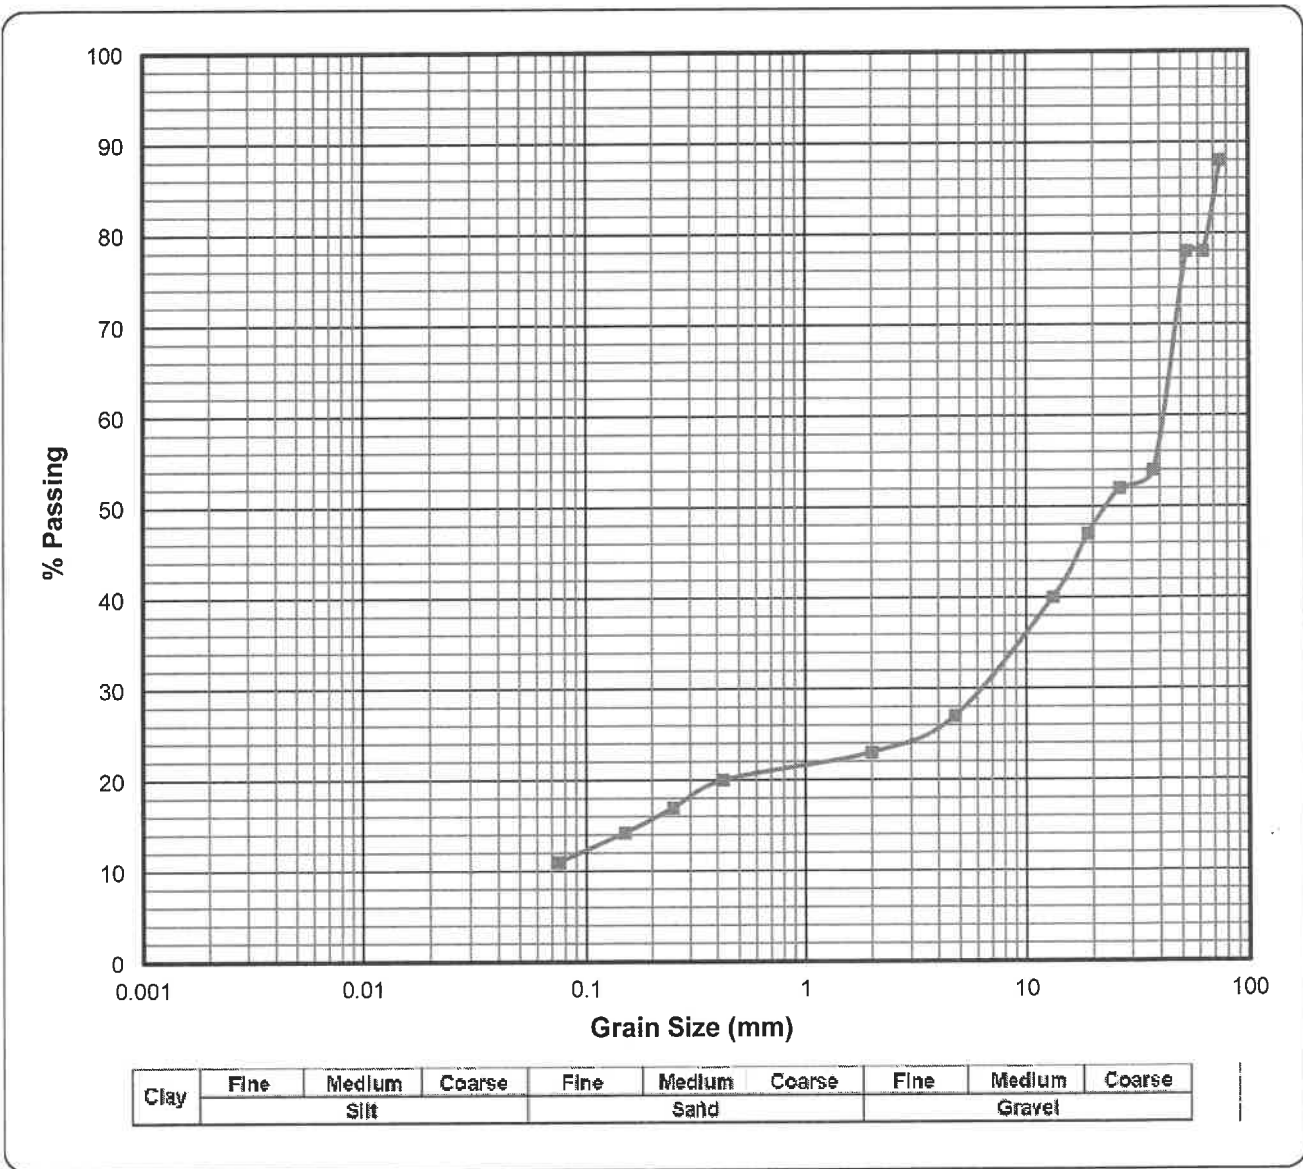
### Grading Curve for Sample 47880 – TMH1 Method A1 (a)

**Thick Red Line is the Grading Curve (TRH 14 Classification = G7)**

Sieve Aperture Size	0.075	0.150	0.250	0.425	2.00	4.75	13.2	19.0	26.5	37.5	53	0	75
Percentage Passing	11%	14%	17%	20%	23%	27%	40%	47%	52%	54%	78%	0%	88%

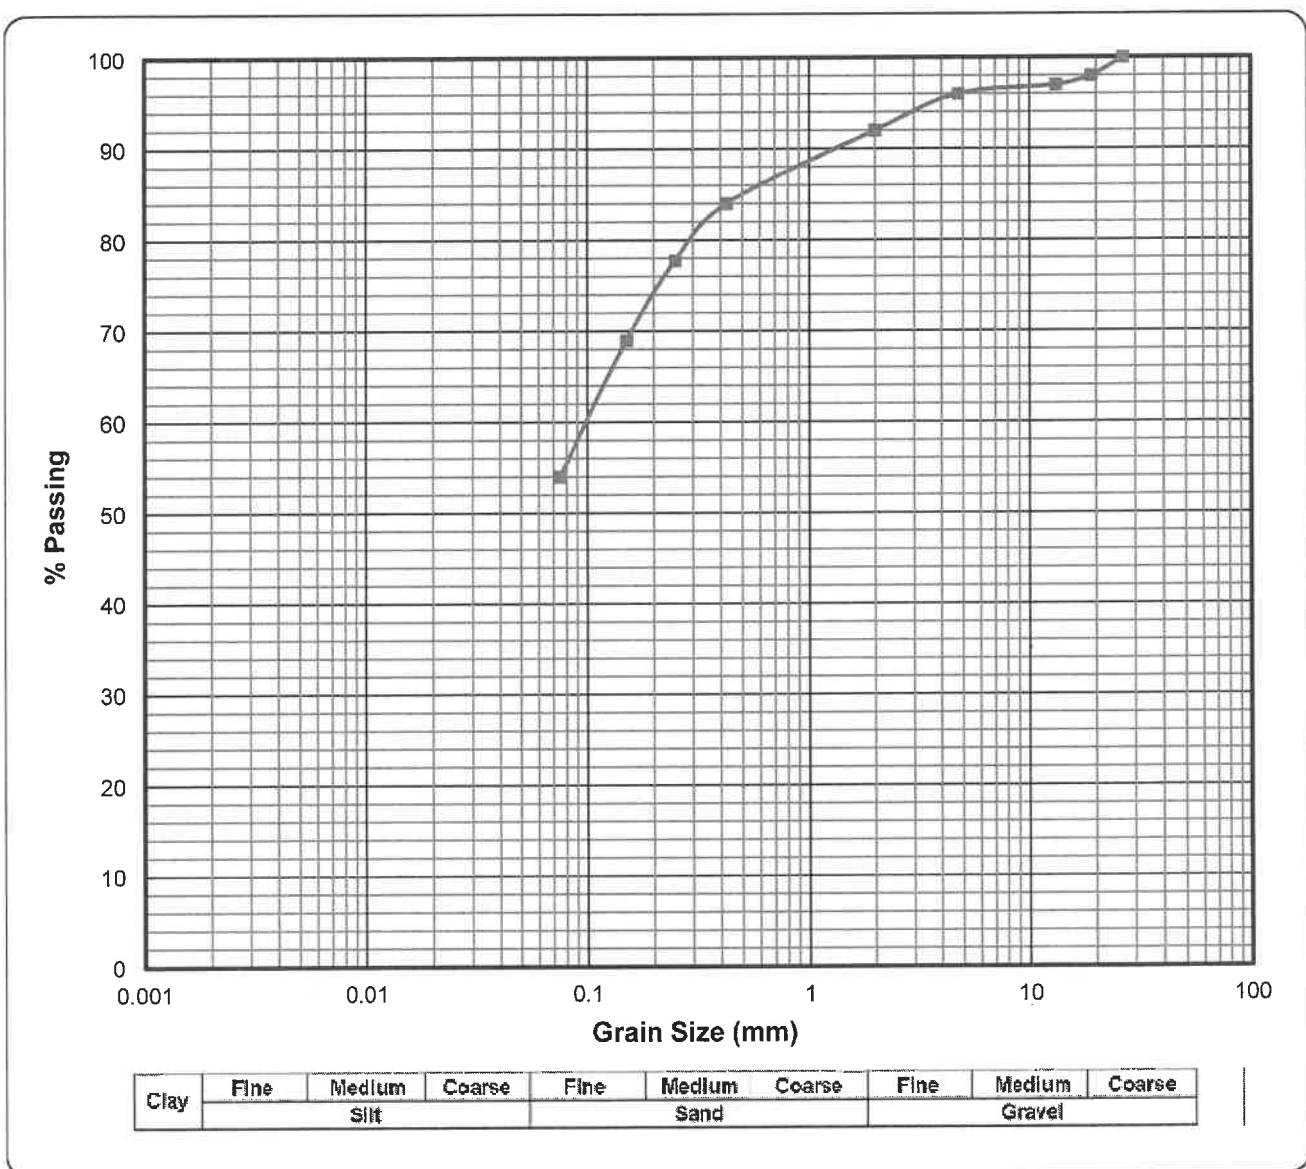
### Grading Curve for Sample 47882 – TMH1 Method A1 (a)

**Thick Red Line is the Grading Curve (TRH 14 Classification = G8)**

Sieve Aperture Size	0.075	0.150	0.250	0.425	2.00	4.75	13.2	19.0	26.5	37.5	53	63	75
Percentage Passing	54%	69%	78%	84%	92%	96%	97%	98%	100%
